Comparison of Pelvis Injury Patterns and Loading Mechanisms in PMHS Tests and Real-World Side Impact Collisions

I. Nazari¹, J. Heo¹, B. Gepner¹, and J. Forman¹

¹ Center for Applied Biomechanics, University of Virginia

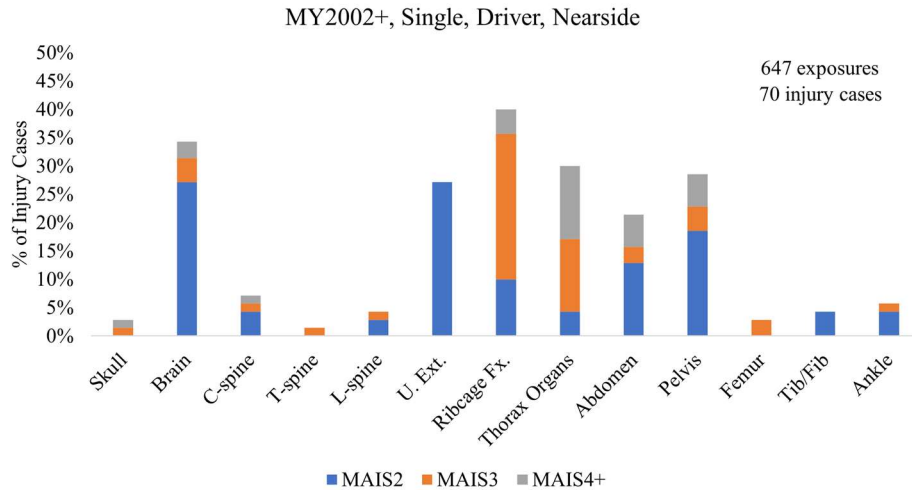
Figure 1: Distribution of AIS2+ injury types in single-event nearside collisions (PDOF 240-300 degrees), by injury severity (CISS collection years 2017-2022, belted driver, MY 2002+, unweighted).

Pelvis fracture is one of the most common types of injuries in side impacts (Samaha and Elliott, 2003). Figure 1 illustrates the prevalence of AIS 2+ pelvis injuries in nearside collisions. These injuries are particularly serious due to their proximity to major organs and arteries including the bladder, spleen, and internal and external iliac arteries. Fractures in the pelvic region can be considered unstable in cases when the integrity of the pelvic ring is compromised. These fractures can be difficult to recover from and create high injury costs for society (Hell et al., 1999).

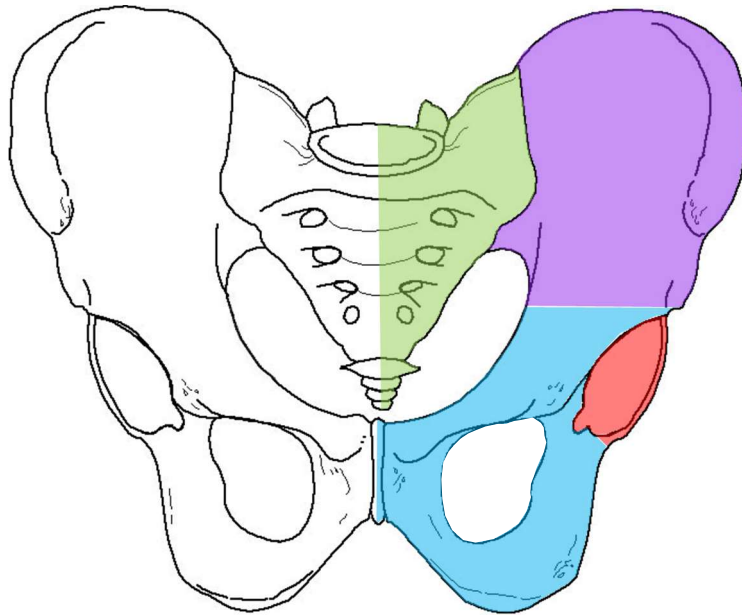
Figure 2: Regions of the pelvis: iliac wing (purple), acetabulum (red), sacroiliac joint (green), and anterior (blue).

Roughly 78% of the PMHS tests selected from the literature were performed on male cadavers compared to 22% on female cadavers. The average age for the PMHS was 66. Out of the 204 tests, 74 (36%) were injurious resulting in a pelvis fracture. 12% of those injurious cases involved fractures to the secondary side of the pelvis that was not struck by the impactor or wall. Fractures were organized into four regions in the pelvis: the iliac wing, acetabulum, sacroiliac joint and sacrum, and the “anterior” region encompassing the superior pubic rami, inferior pubic rami, and pubic symphysis (Figure 2).

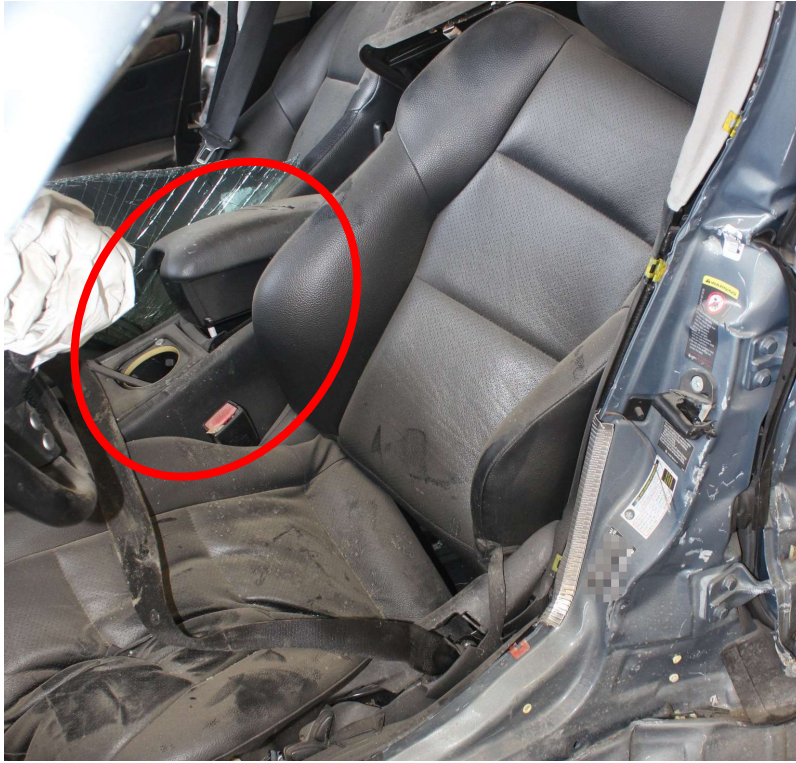
Figure 4: Example of a vehicle with a far side boundary from CIREN case #276

After dividing the CIREN cases into vehicles with a far side boundary and without a far side boundary, there were 22 cases with this boundary and 12 cases without. Figure 4 shows an exemplary vehicle that contains a center console that could interact with the secondary side of the pelvis in a near side crash for the driver. Figure 5 shows an exemplary vehicle that does not contain this boundary and has minimal structures that could interact with the secondary side of the pelvis from the lateral direction. The center console is much lower than the one in Figure 4, so even when the intruding door pushes the pelvis laterally, there is less of a structure for the occupant to interact with. Looking at the four fracture regions again, 64% of CIREN cases with a far side boundary had fractures at the secondary side anterior region, 5% at the secondary side acetabulum, and 27% at the secondary side sacroiliac joint. For the CIREN cases with no far side boundary condition, 58% fractured at the secondary side anterior region and 17% at the secondary side sacroiliac joint. There were no secondary side acetabulum fractures for cases with no far side boundary, and there were no secondary side wing fractures in either scenario. Table 2 displays the comparison of injury proportions in these two vehicle categories.

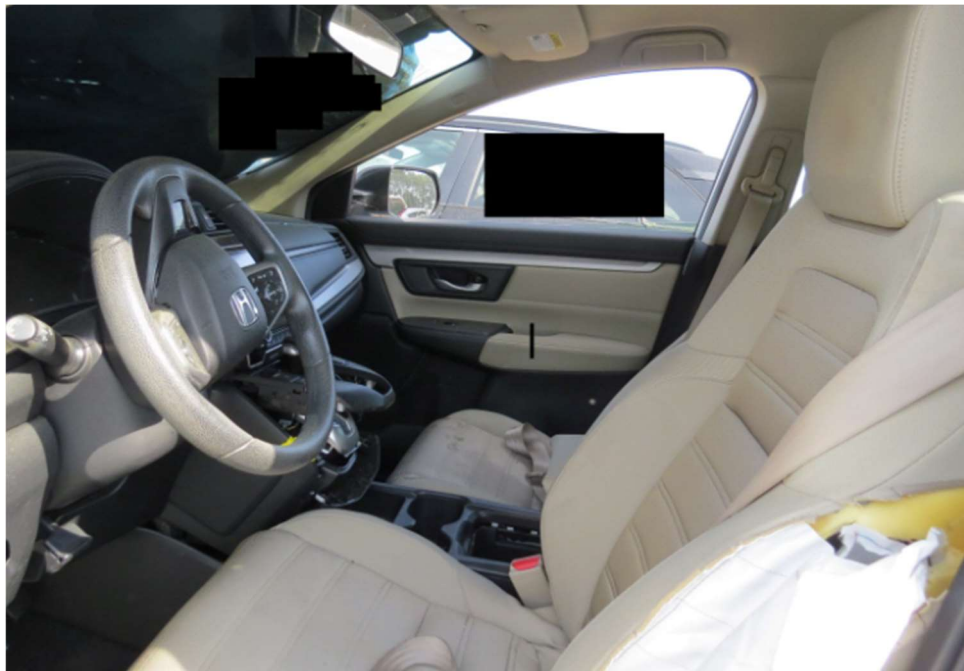
Figure 5: Example of a vehicle without a far side boundary from CIREN case #980035

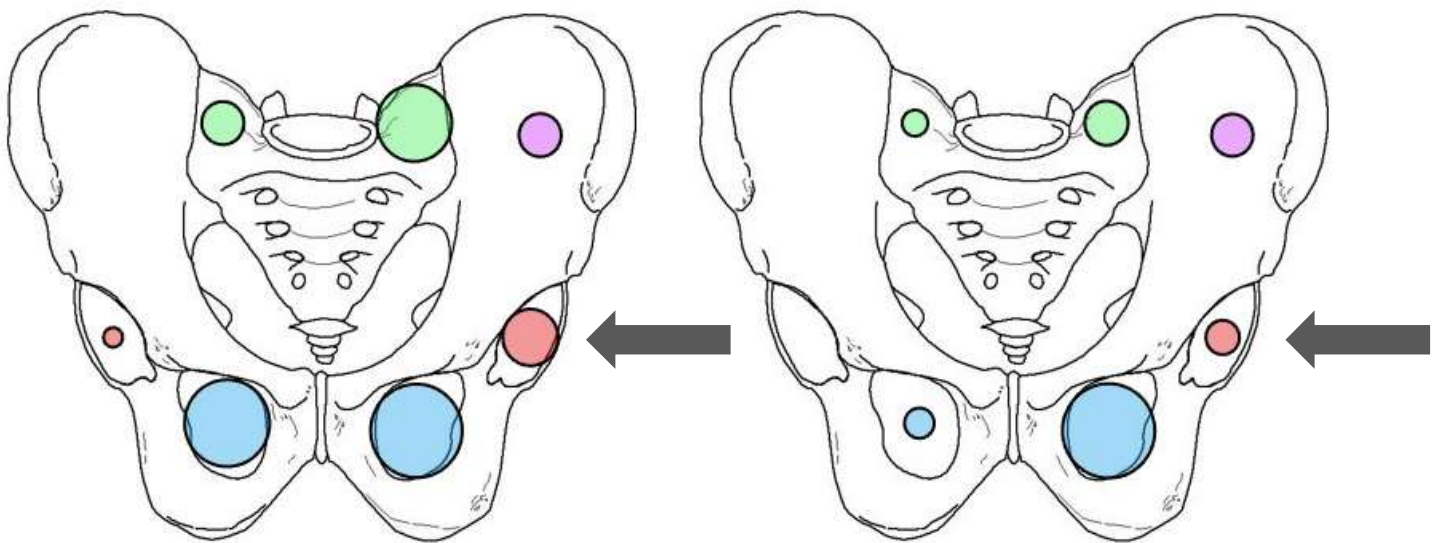
Figure 7: All CIREN cases (left) vs. injurious PMHS tests (right) where the arrow depicts the direction of primary impact, and the radius of the circle depicts the proportion of pelvis injury cases that had a fracture in that region.

Comparing secondary side fractures occurring in PMHS tests to those occurring in all the CIREN cases, there is an overall increase in the proportion of impacts with anterior, acetabular and sacroiliac joint fractures. This could be caused by interaction with other structures in the vehicle. The secondary side fractures in the PMHS tests were most likely due to a combination of inertial load due to the original impact and a transfer of forces through the sacroiliac joints or pubic symphysis. The transfer of forces may be greater for subjects with osteoporosis, osteopenia, or weaker bone in general. This bone quality may correlate with older subjects (Oberkircher, 2018). The increase in secondary side fractures in the CIREN cases shows a potential difference in the injury patterns observed in the PMHS tests and the real-world cases that may not be accounted for solely by the center console. The comparison of PMHS test and CIREN case fracture locations and proportions can be found in Figure 7.
